Mid-Year Monitoring Memorandum

HILTON HEAD PUBLIC SERVICE DISTRICT RECYCLED WATER PROJECTS *Hilton Head Plantation and Palmetto Hall, Hilton Head Island, SC*

July 2017

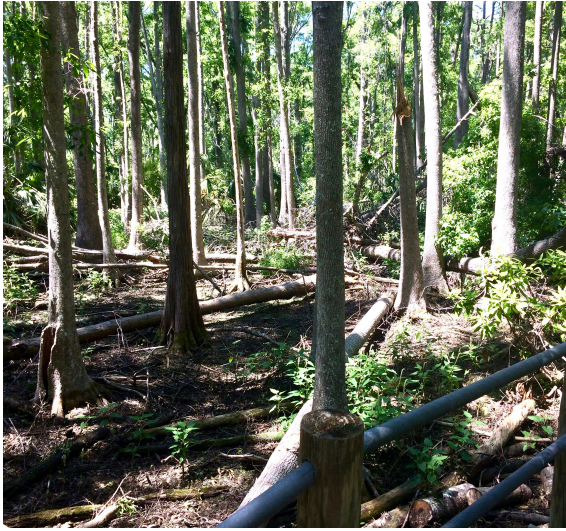
Cypress Conservancy is the last large enclave of rare bald and pond cypress trees on HHI. This habitat receives less recycled water. Hurricane blow-down of trees, primarily in Cypress Swamp, occurred on the windward (facing north-northwest) perimeter of the wetlands. The palisade of fallen trees served as a protective wind barrier shielding not only the interior of the wetlands, but also homes, golf courses, roads, and infrastructure.

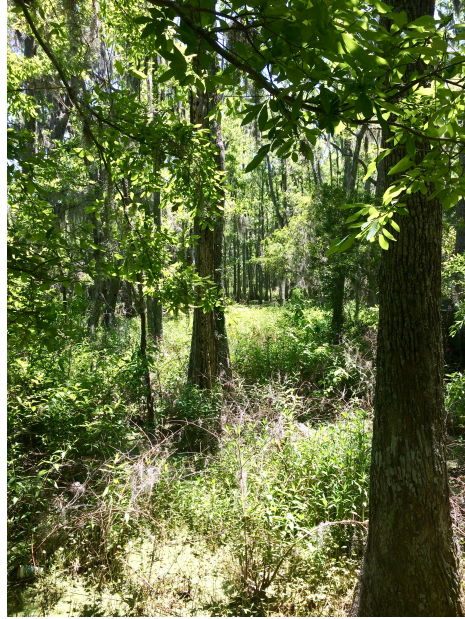
Whooping Crane Pond Conservancy

Flooding took place in several areas of the wetlands. Although the RW habitats are innately suited to accommodate water, *too much* water became a problem in WCC. The mass of windblown water breached a dike in WCC, and this allowed a large quantity of water to flow into adjoining areas and properties. It is important to note, however, that the mass of water has receded and did not damage the RWP infrastructure—only several walking trails nearby. These areas have since been restored.

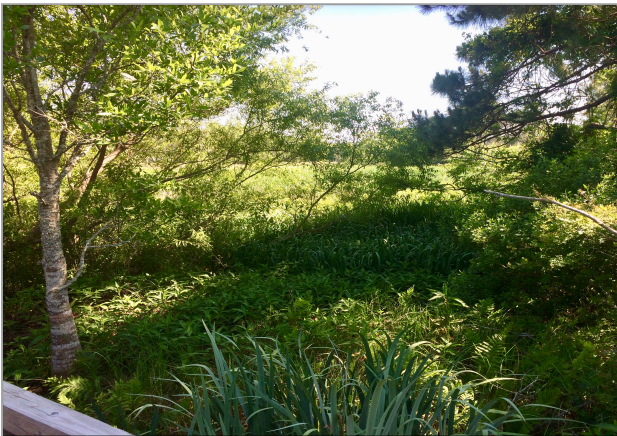
The Grassy Wetland appears to be the least affected by the hurricane. It was generally dry with shallow water collecting in the center and perimeters of the wetland. Compared to the Wooded Wetland, Grassy had few trees down and very little erosion. Strong rain and winds did convey sediment into the wetland, which may have caused dieback of groundcover.

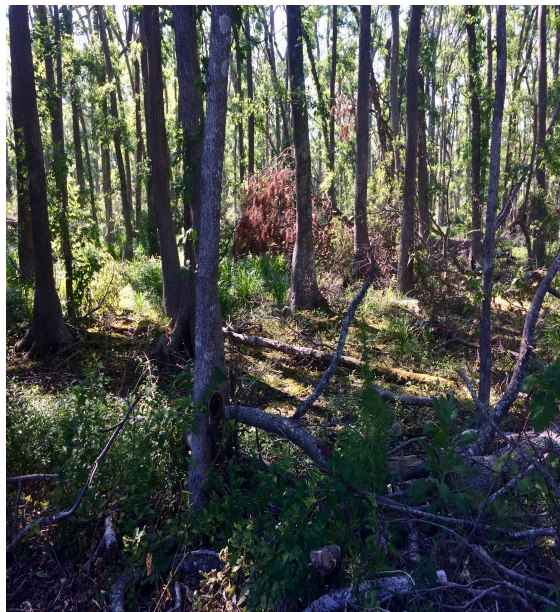
Wooded Wetland

However, the Wooded Wetland, a bottomland hardwood forest, is similar to Hilton Head Plantation's WCC. This past year, the effect of the hurricane was similar, except for a stand of young trees on the northeastern corner of the eastern flank of the property that faced strong winds surging across Port Royal Sound.
